## Part 4 – Preliminary Assessment #2

# Assessments and Inspections

## The Building Inspection – The Most Important Aspect of the Project

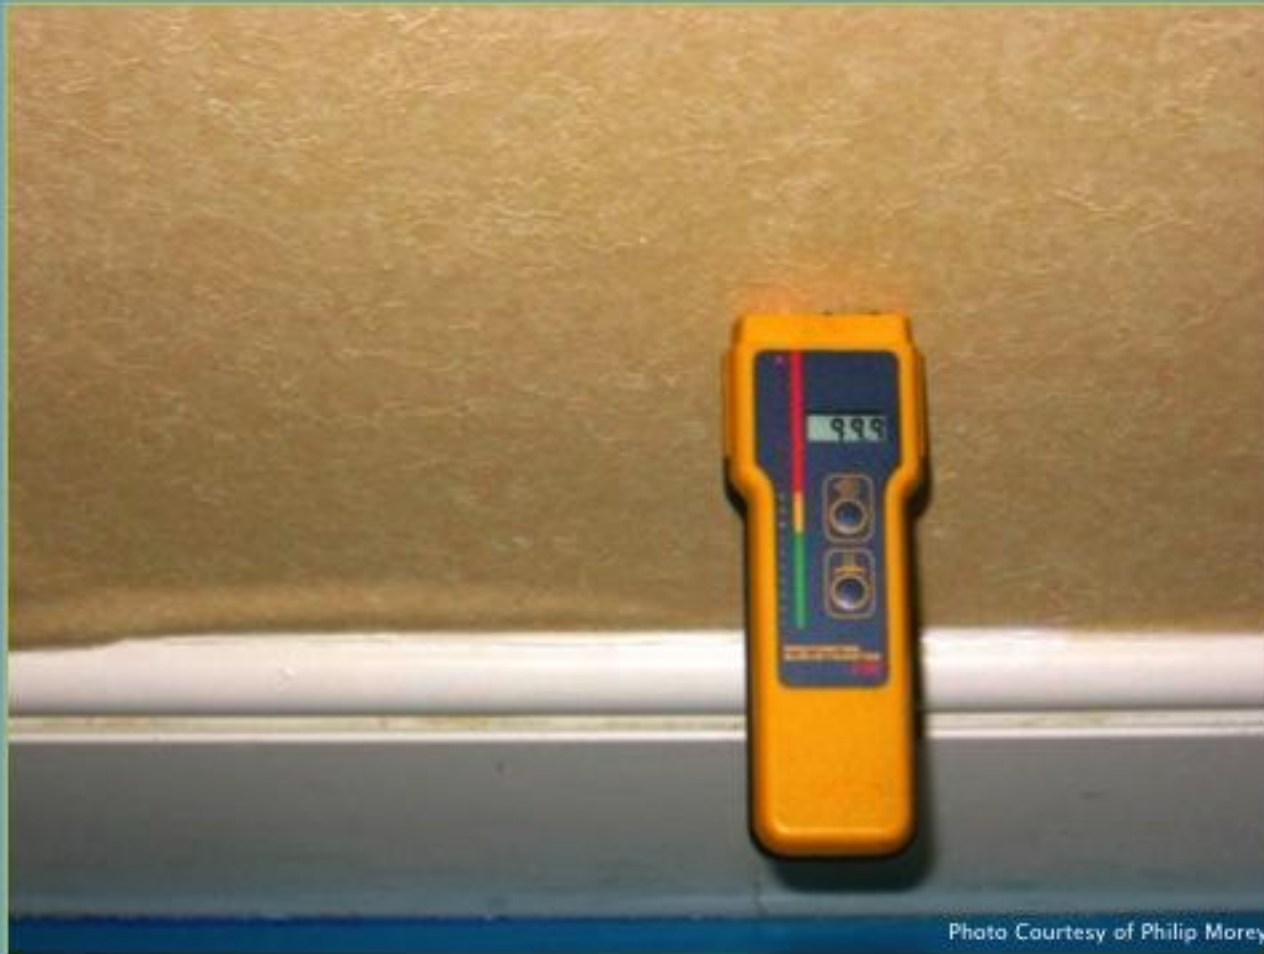
# Wallboard behind vinyl wall covering saturated with water

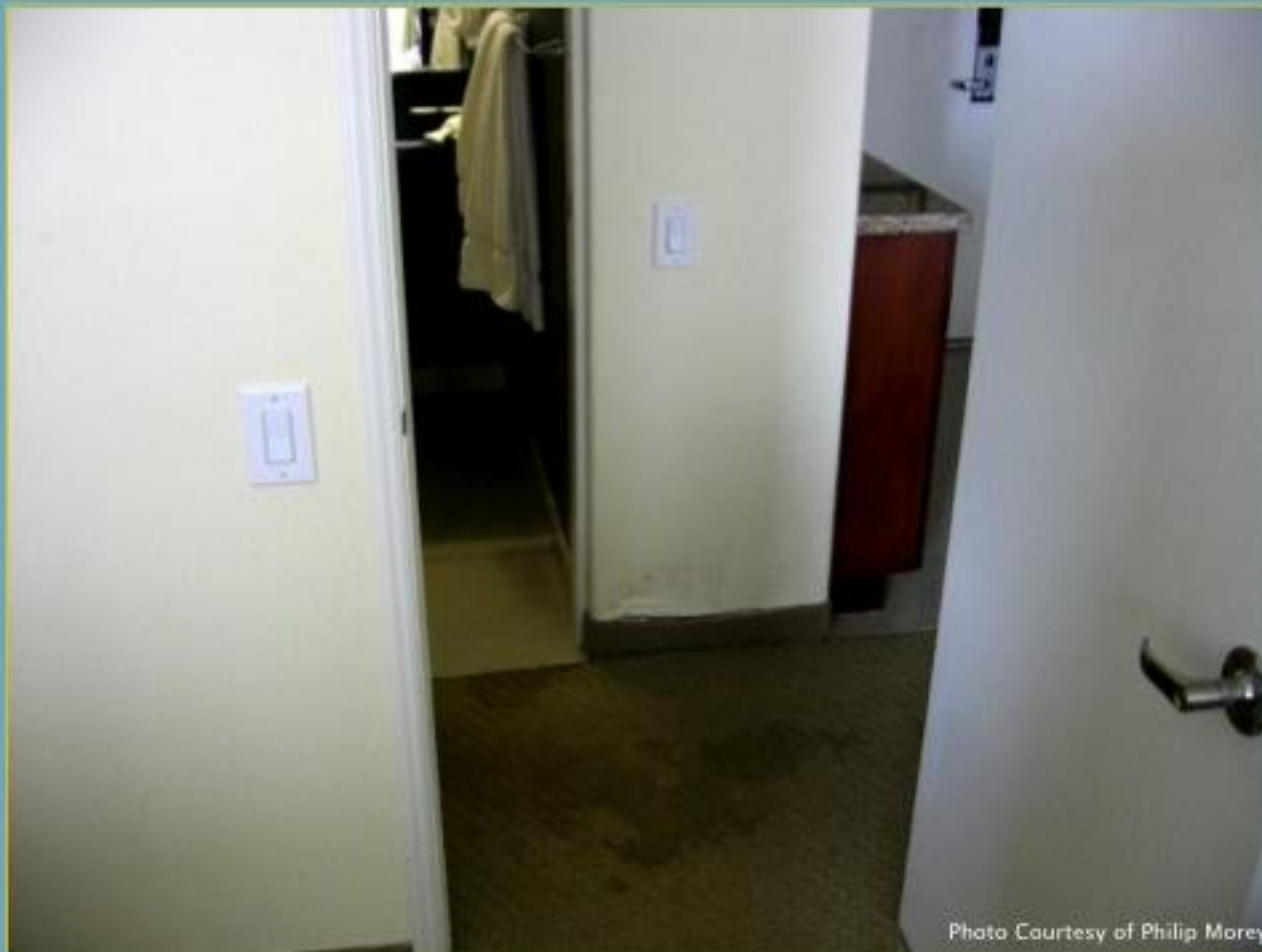
## Inspection: Water damage; Small scale mold?

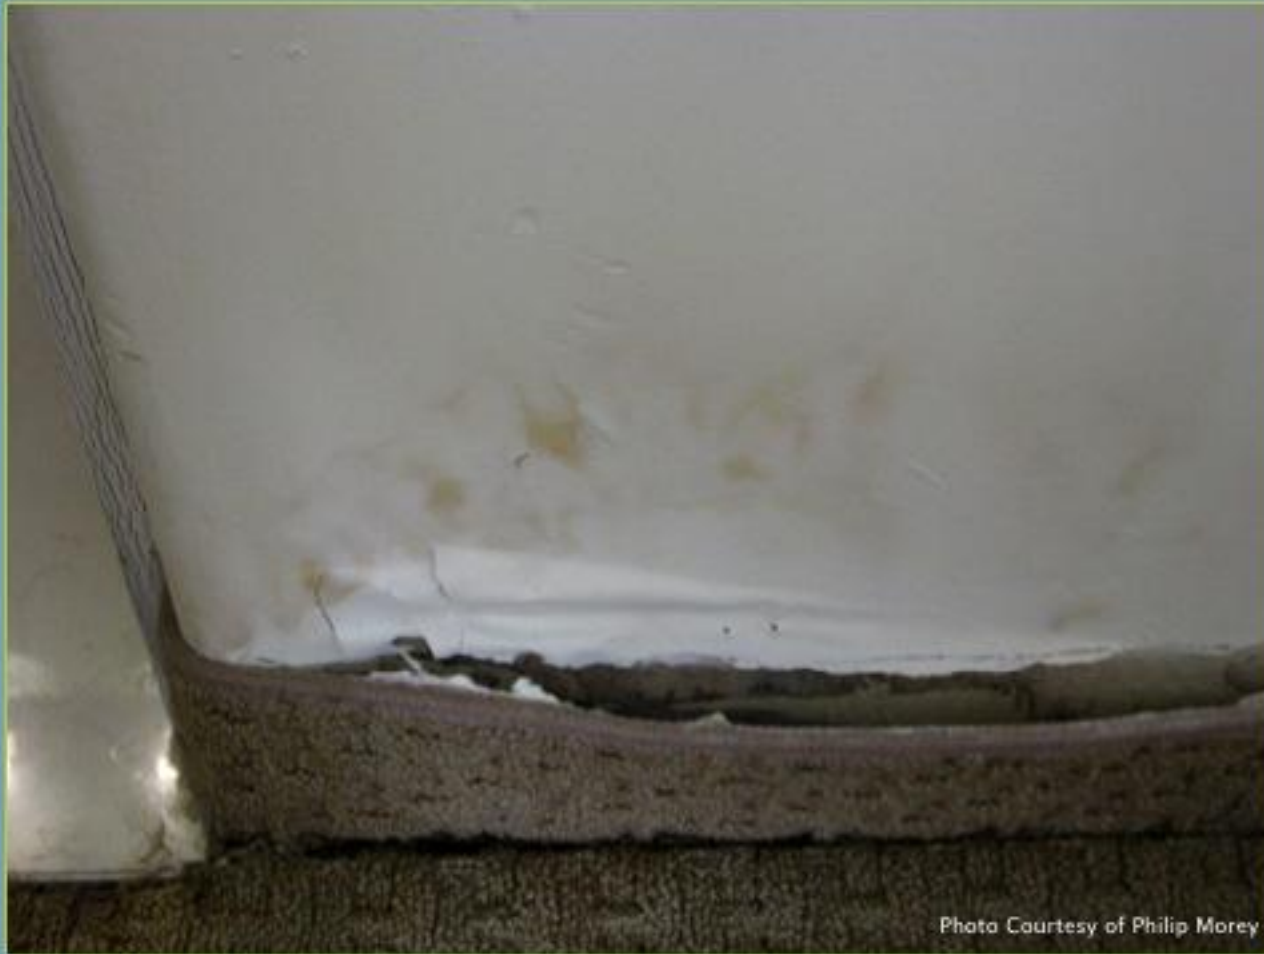
## Small scale mold? Follow the water!!

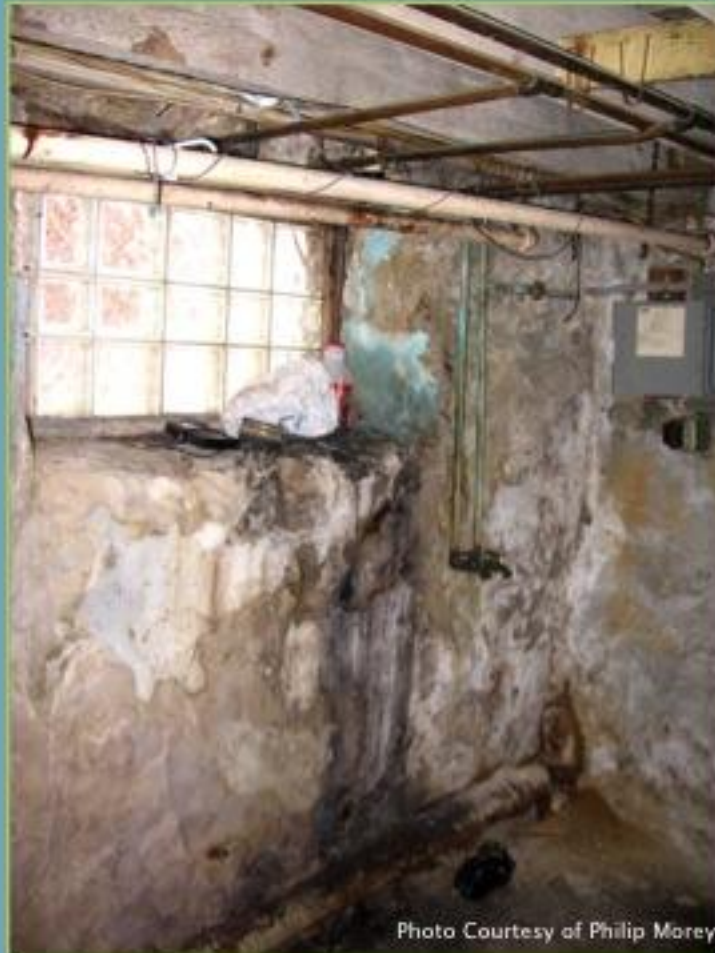
# Historic Water Damage

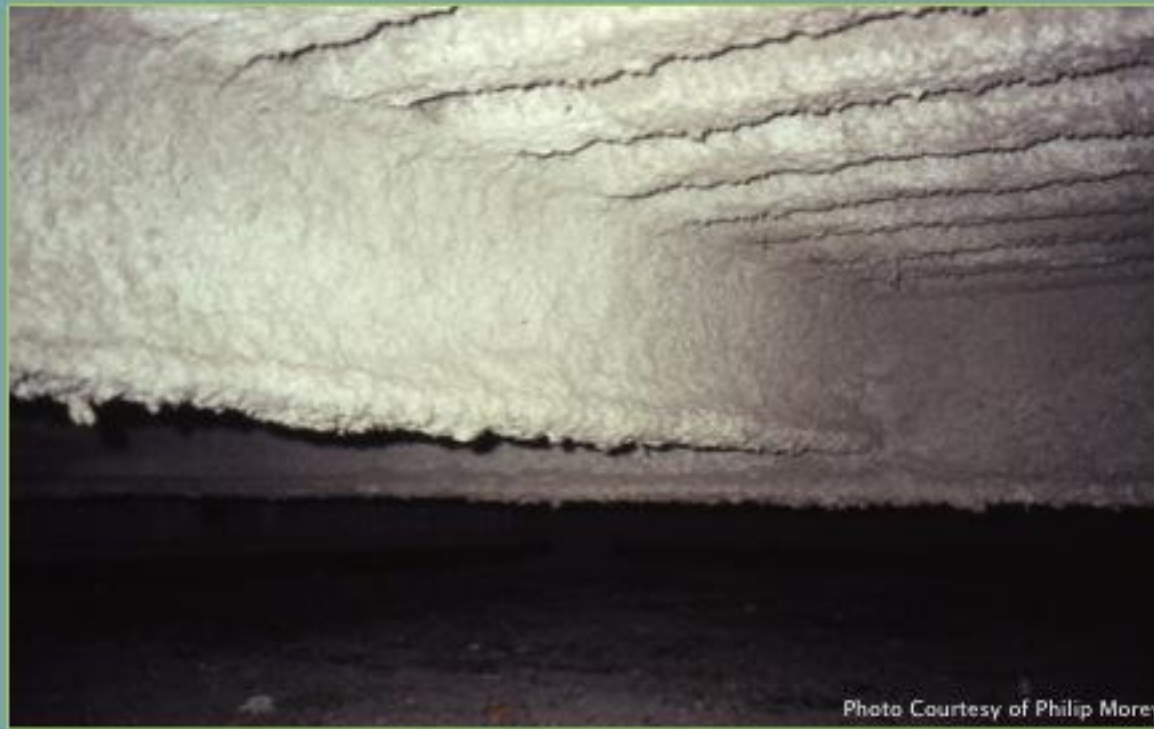
# Cellulosic Spray-On Fire Proofing Applied Wet During Construction

Fireproofing that is applied wet to structural surfaces must be allowed to dry within the time frame recommended by the manufacturer.

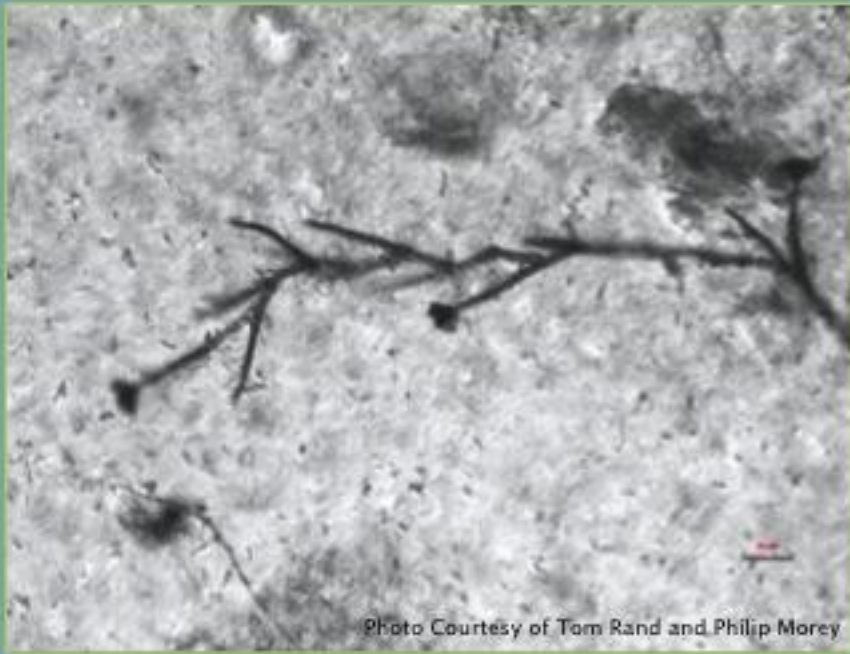
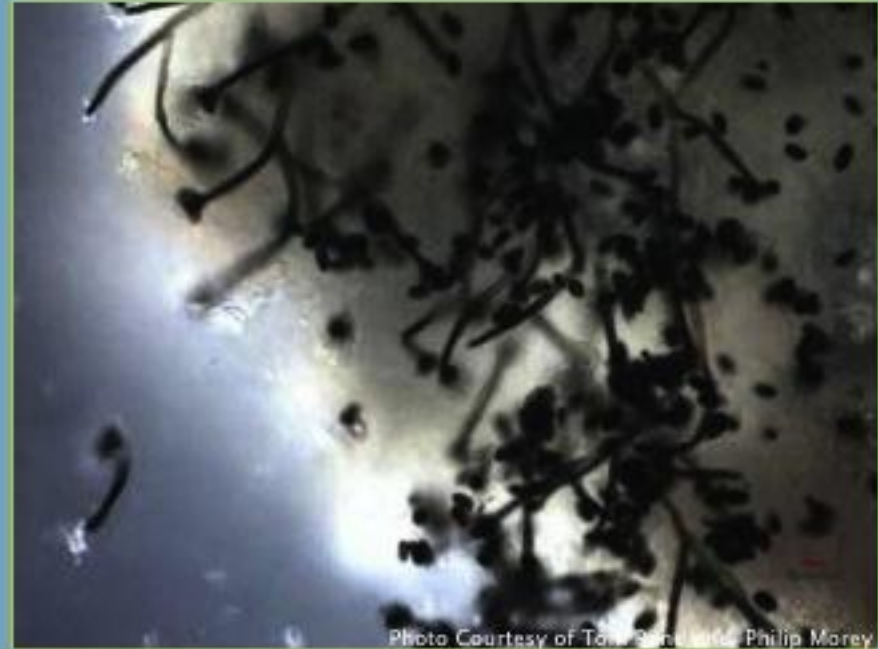
Abundant Stachybotrys spores and conidiophores are present in the wet-applied cellulosic fireproofing sprayed on ceilings and beams in a new building. The moldy fireproofing was removed and replaced with a fireproofing containing a minimal amount of biodegradable components.

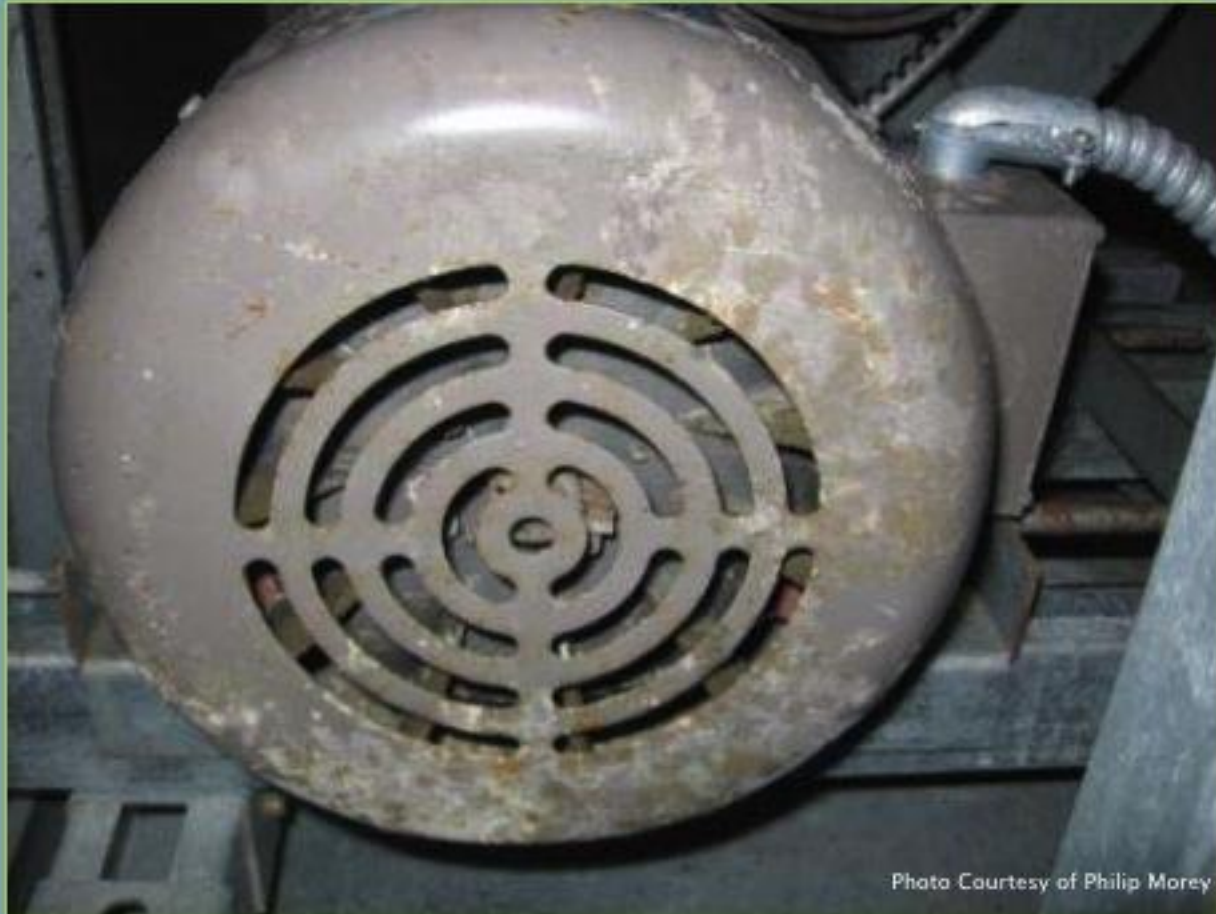
The fine dust and oily film on the metal surface of the fan motor in this under maintained air-handling unit provide nutrients for the growth of mold which is visible on the fan housing.

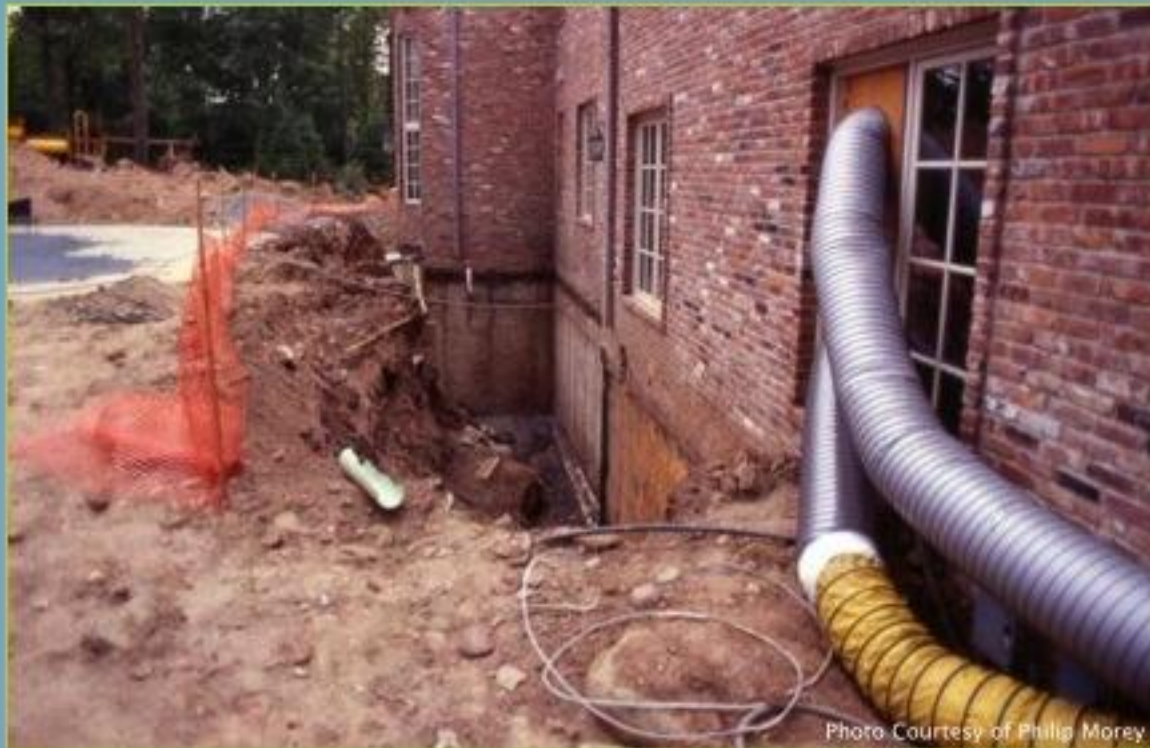
## The Multi-Million Dollar House: Foundation Problem Shortly After Completion of Construction

Note absence of water proofing on outside foundation wall;  
also, water in yard runs toward building; MVOC Sampling;  
Basement under containment

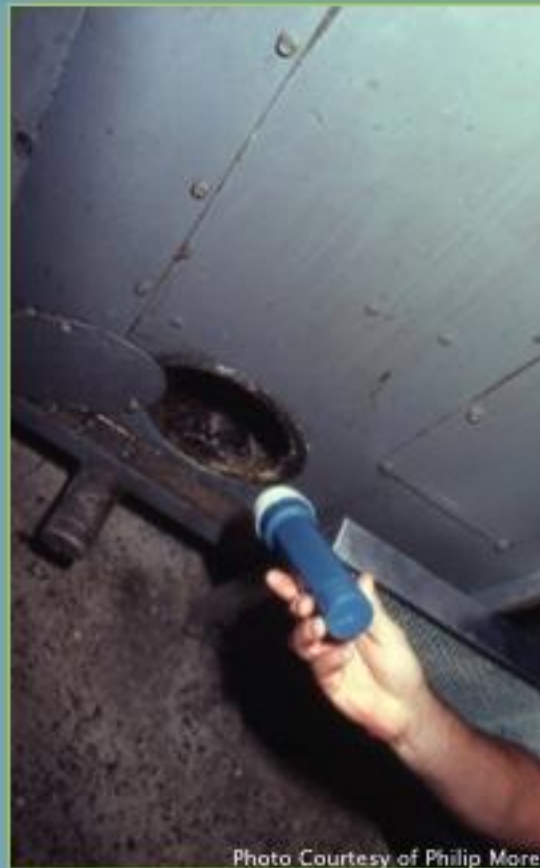
# Design Failure in Air Handling Unit in Cooling Coil Area

Access to drain pan too small for entry by even the smallest human

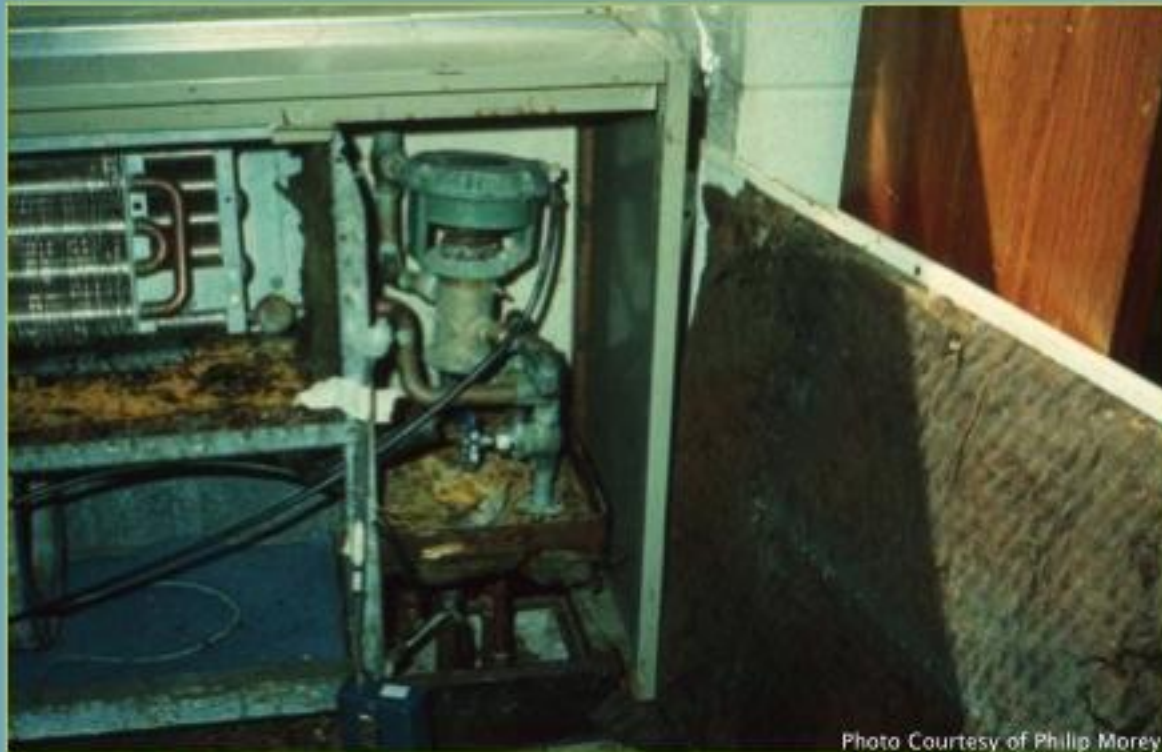
## Maintenance Difficulty in Large Building With Hundreds of Perimeter Fan Coil Units (FCUs)

Maintenance is infrequent because of budget limitations and because of the many FCUs involved. An HVAC design with a few large air handling units may have been a better fit for a limited budget.

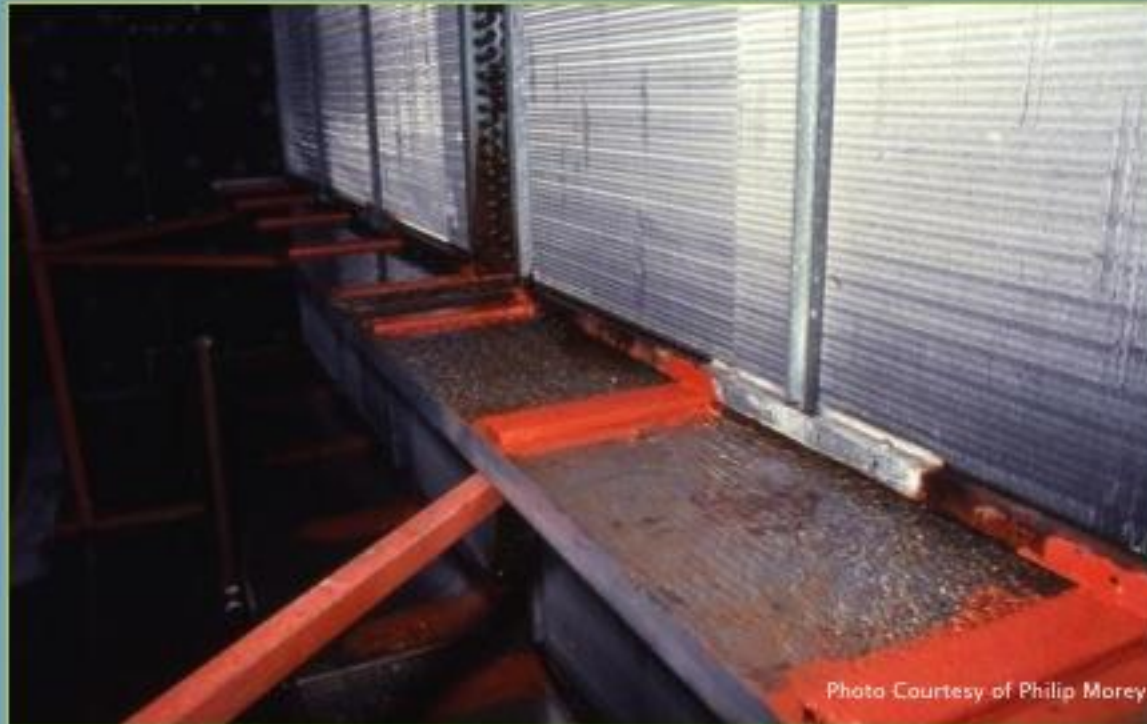
## Maintenance Problem After Construction

Standing water is present in the drain pan; the air velocity over the pan is elevated so that downstream surfaces are being wetted

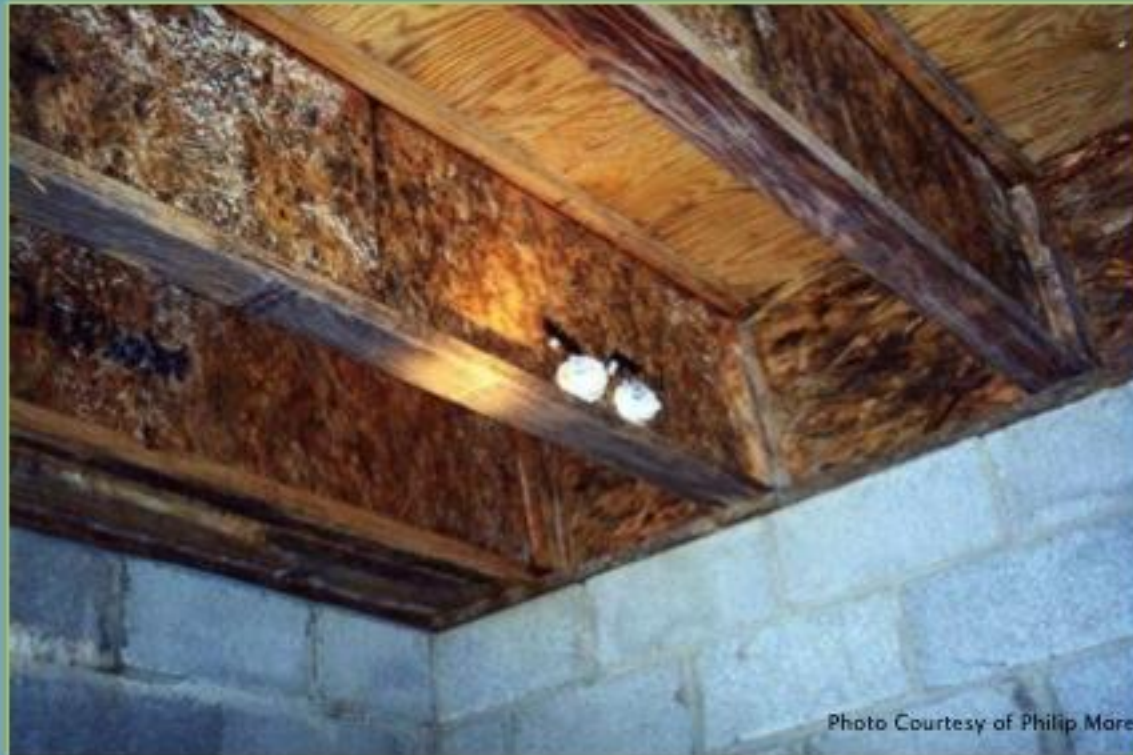
## Moisture Failure In Crawl Space During Construction

RH in crawl space 75 to 95%;  
Note mold growth on OSB

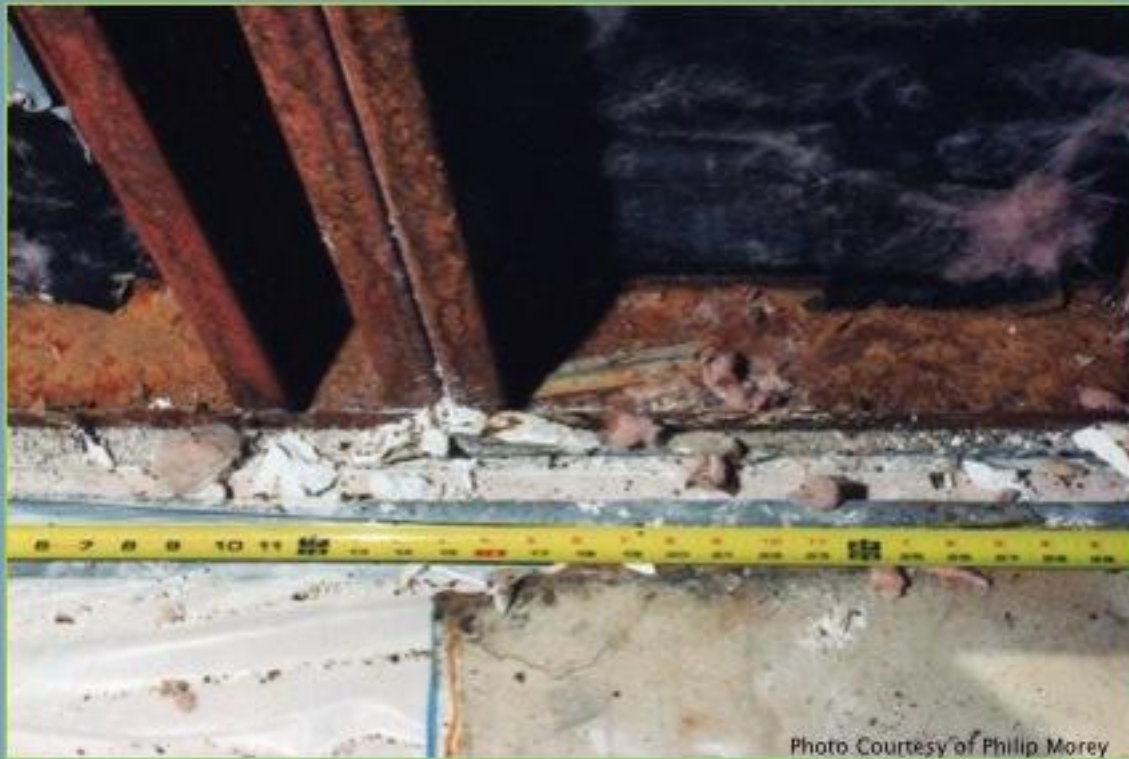
## Moisture Failure in New Building; Why Is It Important?

Rusted metal framing and sill plate in a new building; What else is deteriorated?

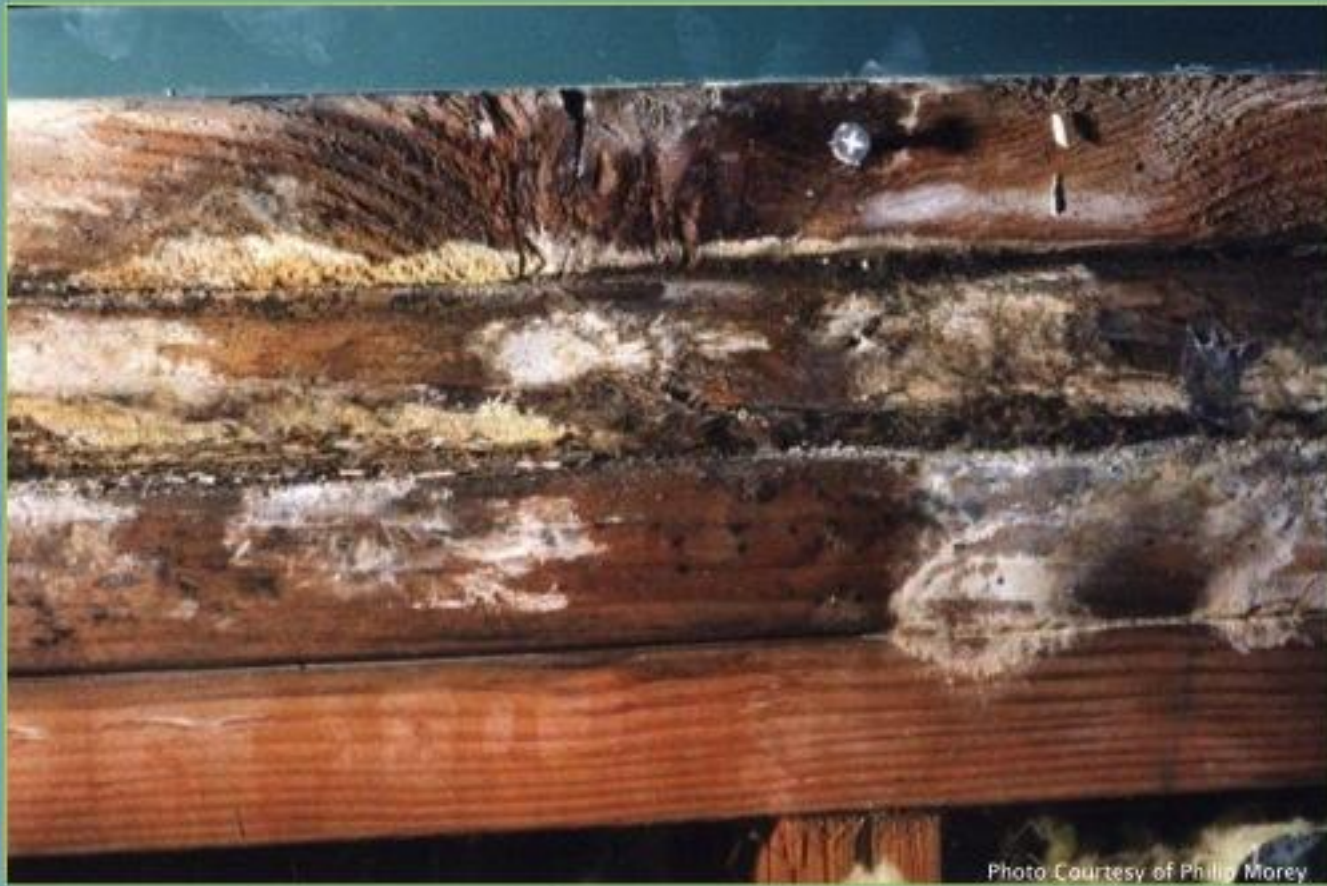
## Moisture Intrusion in New Building: Why Is It Important?

Framing mold in a window assembly:  
EIFS; Window leaks

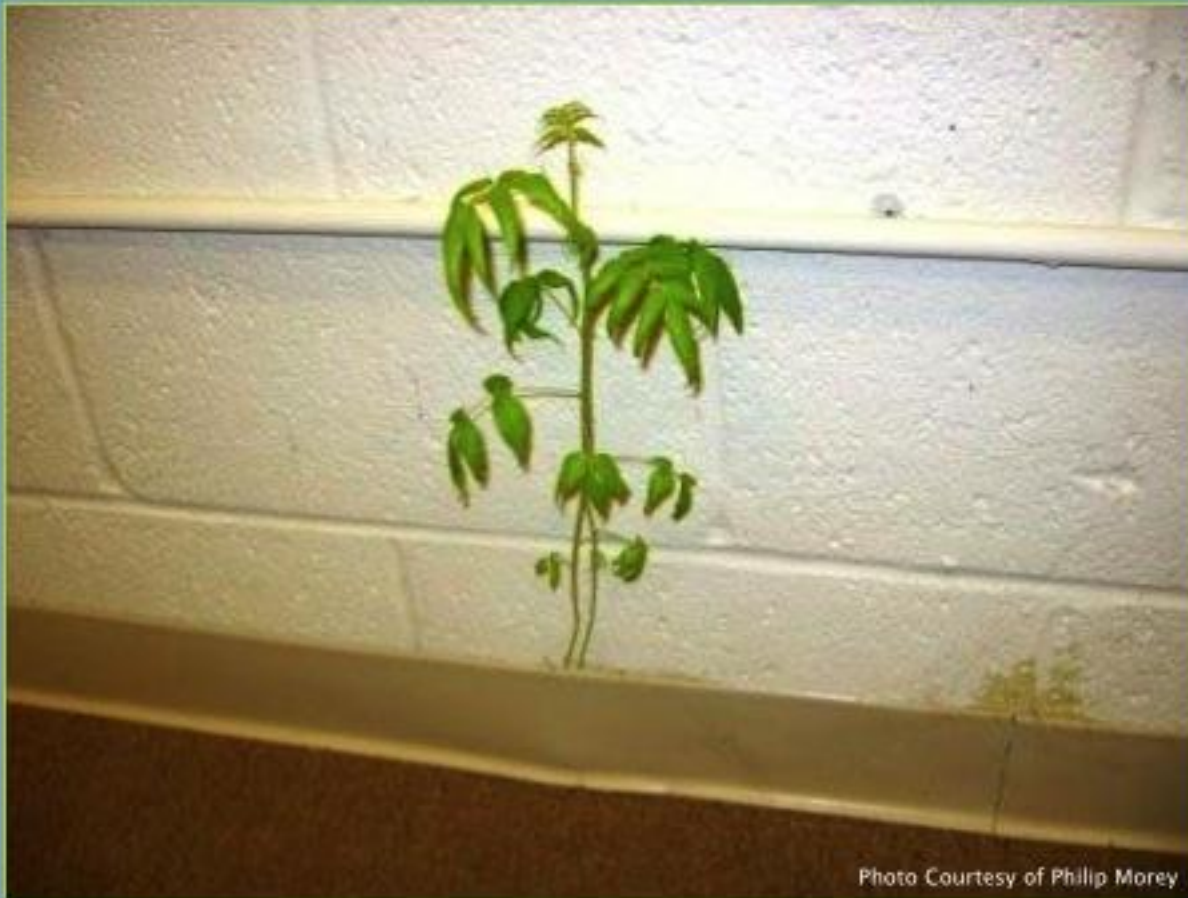
This plant is growing in a well-lighted room along a envelope wall. Moisture infiltrating through the wall and nutrients in the baseboard and carpet provide favorable conditions for plant and microbial growth.

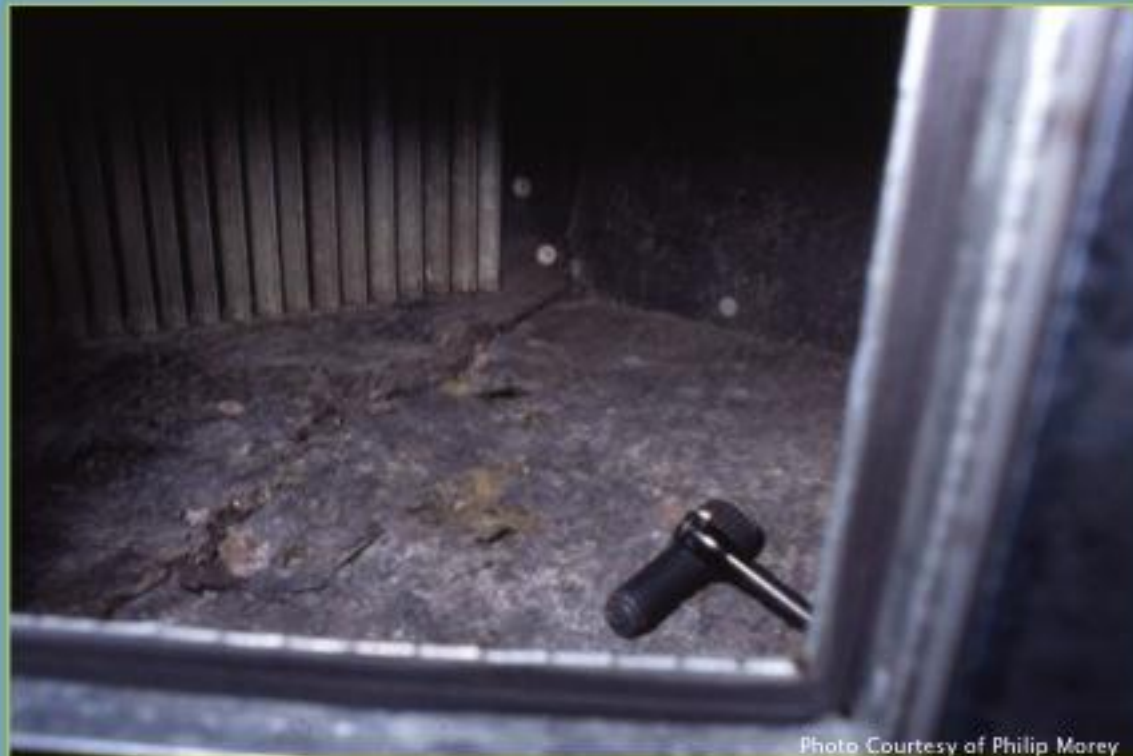
## Design Failure in Air Handling Unit Return Air Plenum in Hospital HVAC

Porous Liner; Dust Accumulation; Skin Scale Accumulation;  
Is This Important in a Hospital?

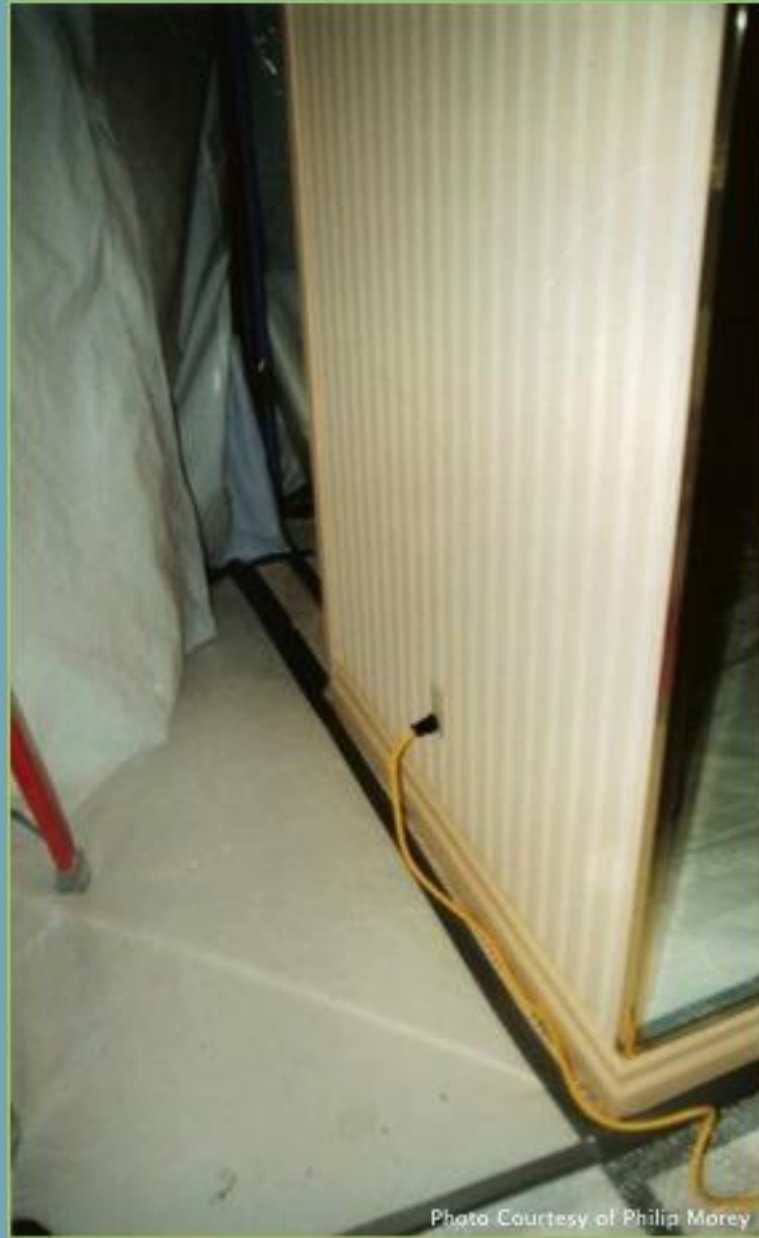
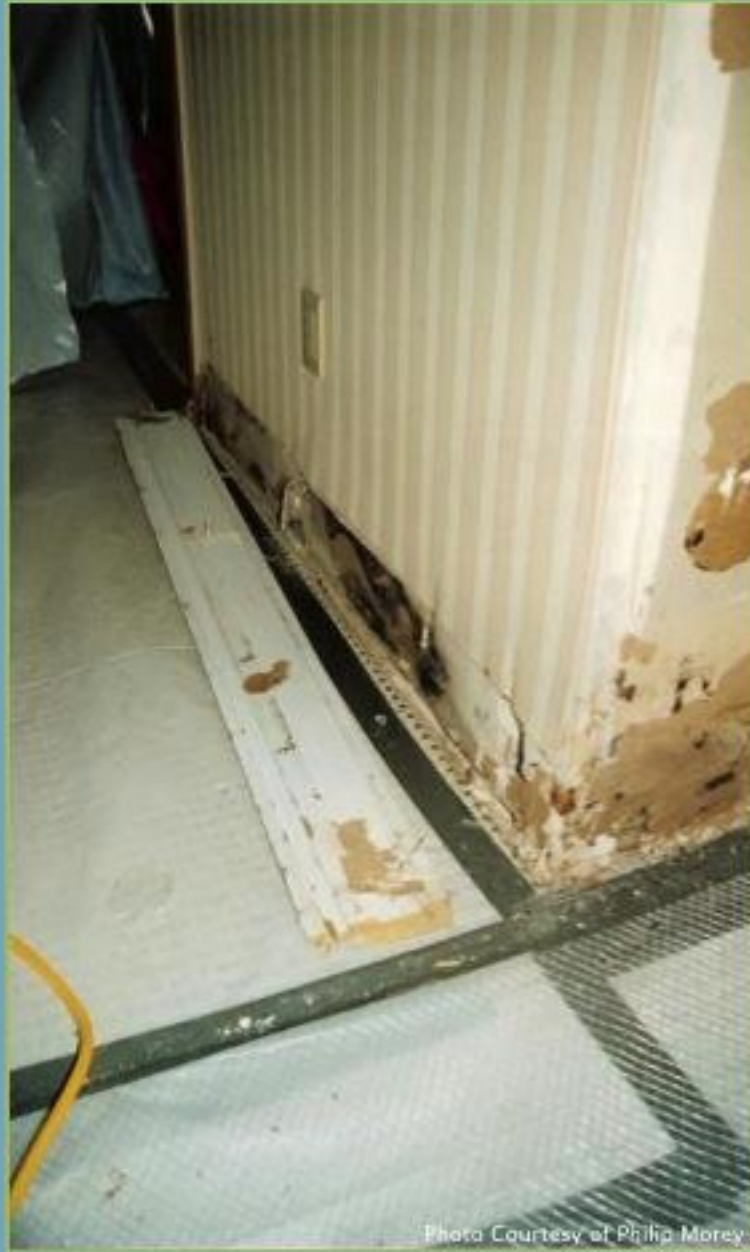
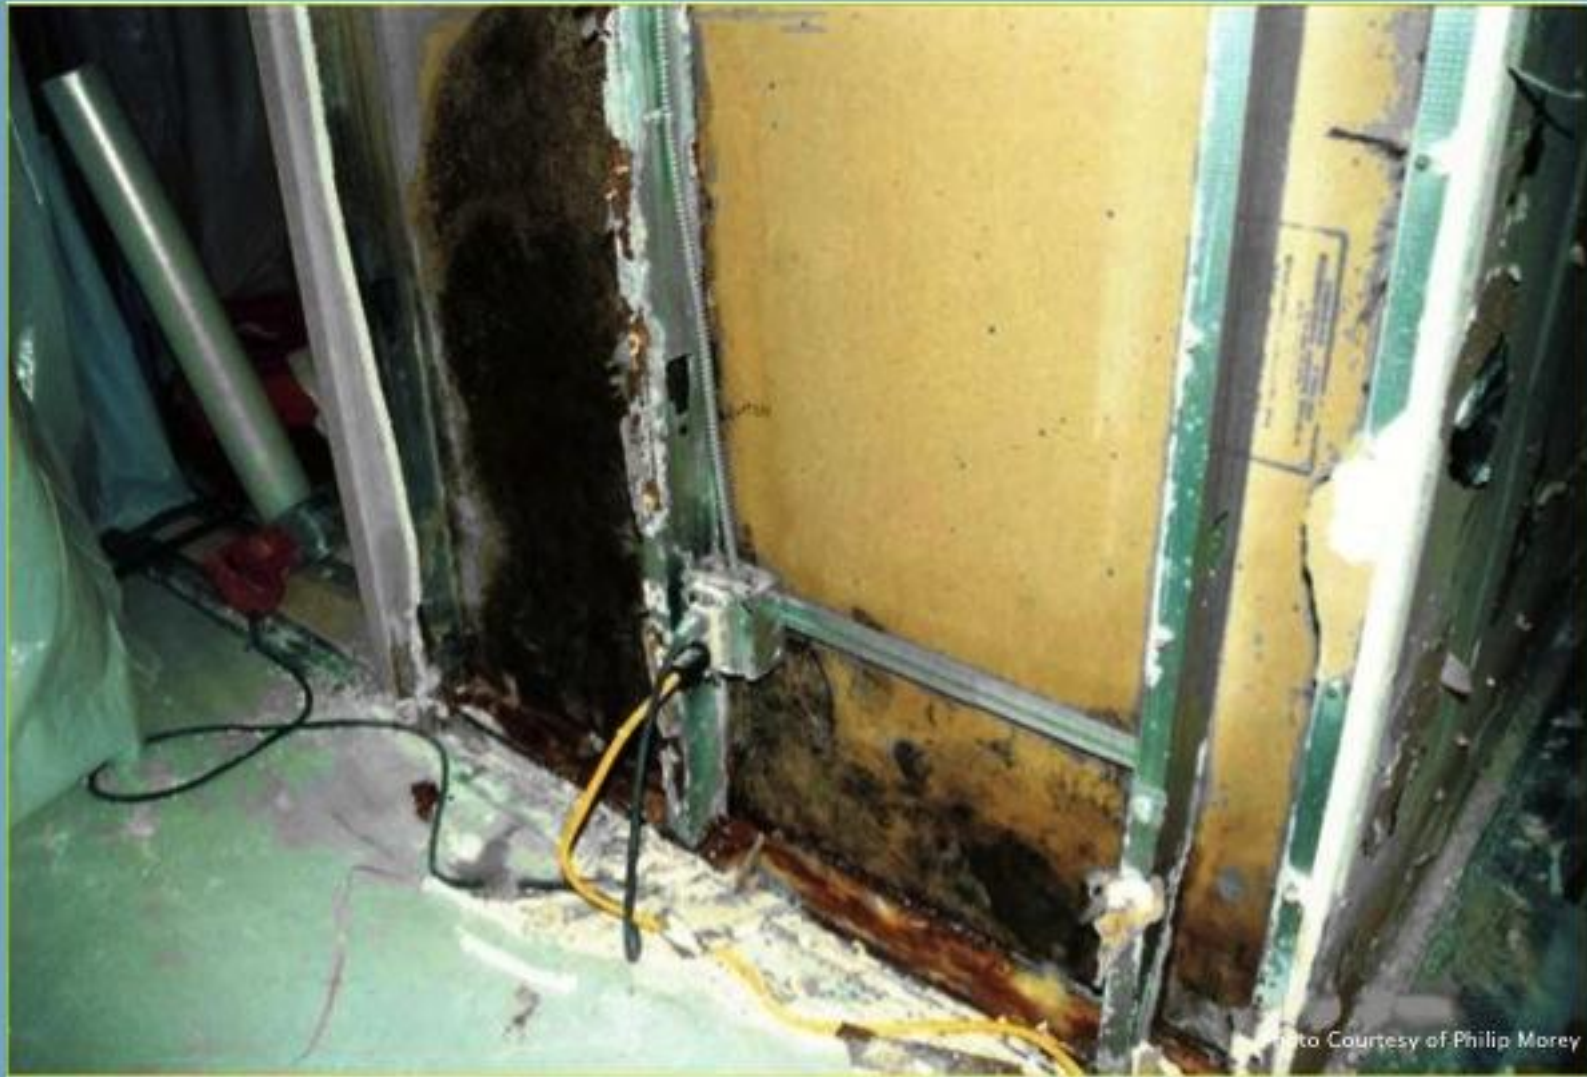
# If There Are Serious Concerns About Hidden Mold Growth and Biodeterioration in a Wall

- Open-up Walls In Representative Areas To See If Visible Mold Growth Occurs
- Characterize The Amount ( $M^2$ ) Of Mold Growth; The Materials Affected By Mold Growth; The Nature Of The Water Problem
